# **KING CITY CIVIC CENTER**

## **CLUBHOUSE POOL ASSESSMENT**

Bradford Consulting Engineers, Inc.

January 23, 2024

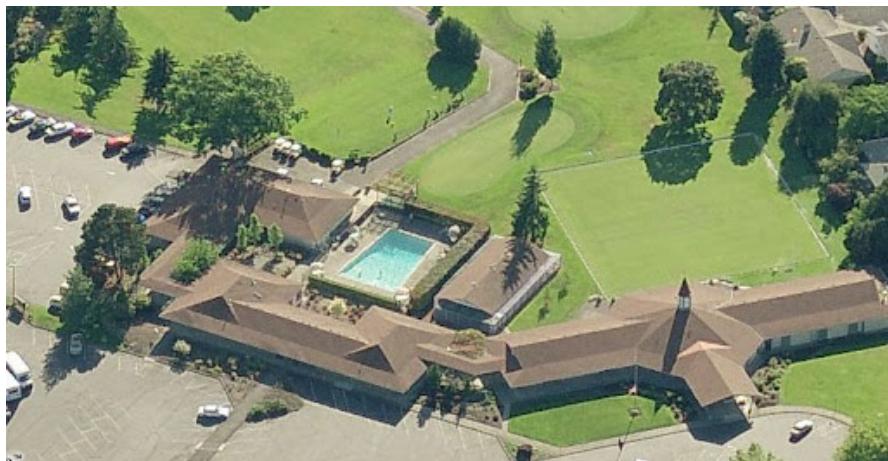
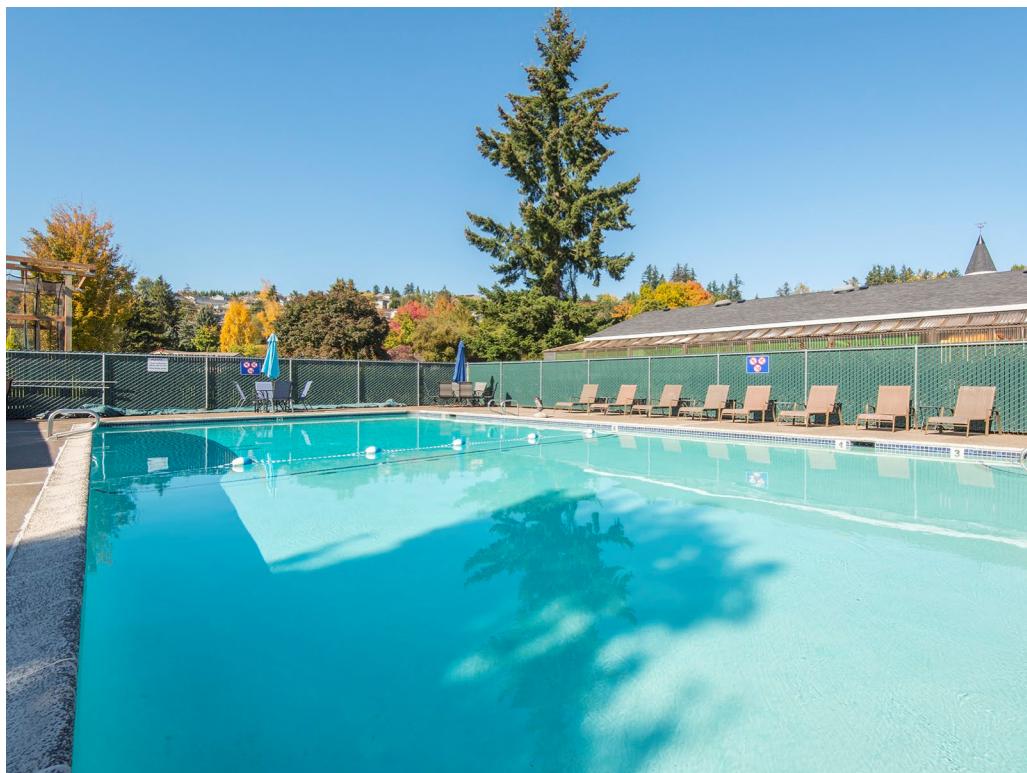
NOTE: PHOTOS FROM KCCA WEBSITE

As mentioned in Section 2.0, the existing pool was built in 1964-1965. The Pool depth ranges from the shallow end on the east to the deep end on the west of approximately 8-9 feet deep. The West end of the pool is 35' wide. The east end of the pool is 25' wide. The overall length of the pool is 50'. There are 5 valves set in the pool deck. There are 4 skimmers in the pool. The pool deck width ranges from 8' to 15'. There are two ladders in the pool near the deep end. There is a single drain in the deep end of the pool.

The pool is surrounded by a fence. Locker rooms in the pro shop serve the pool also.

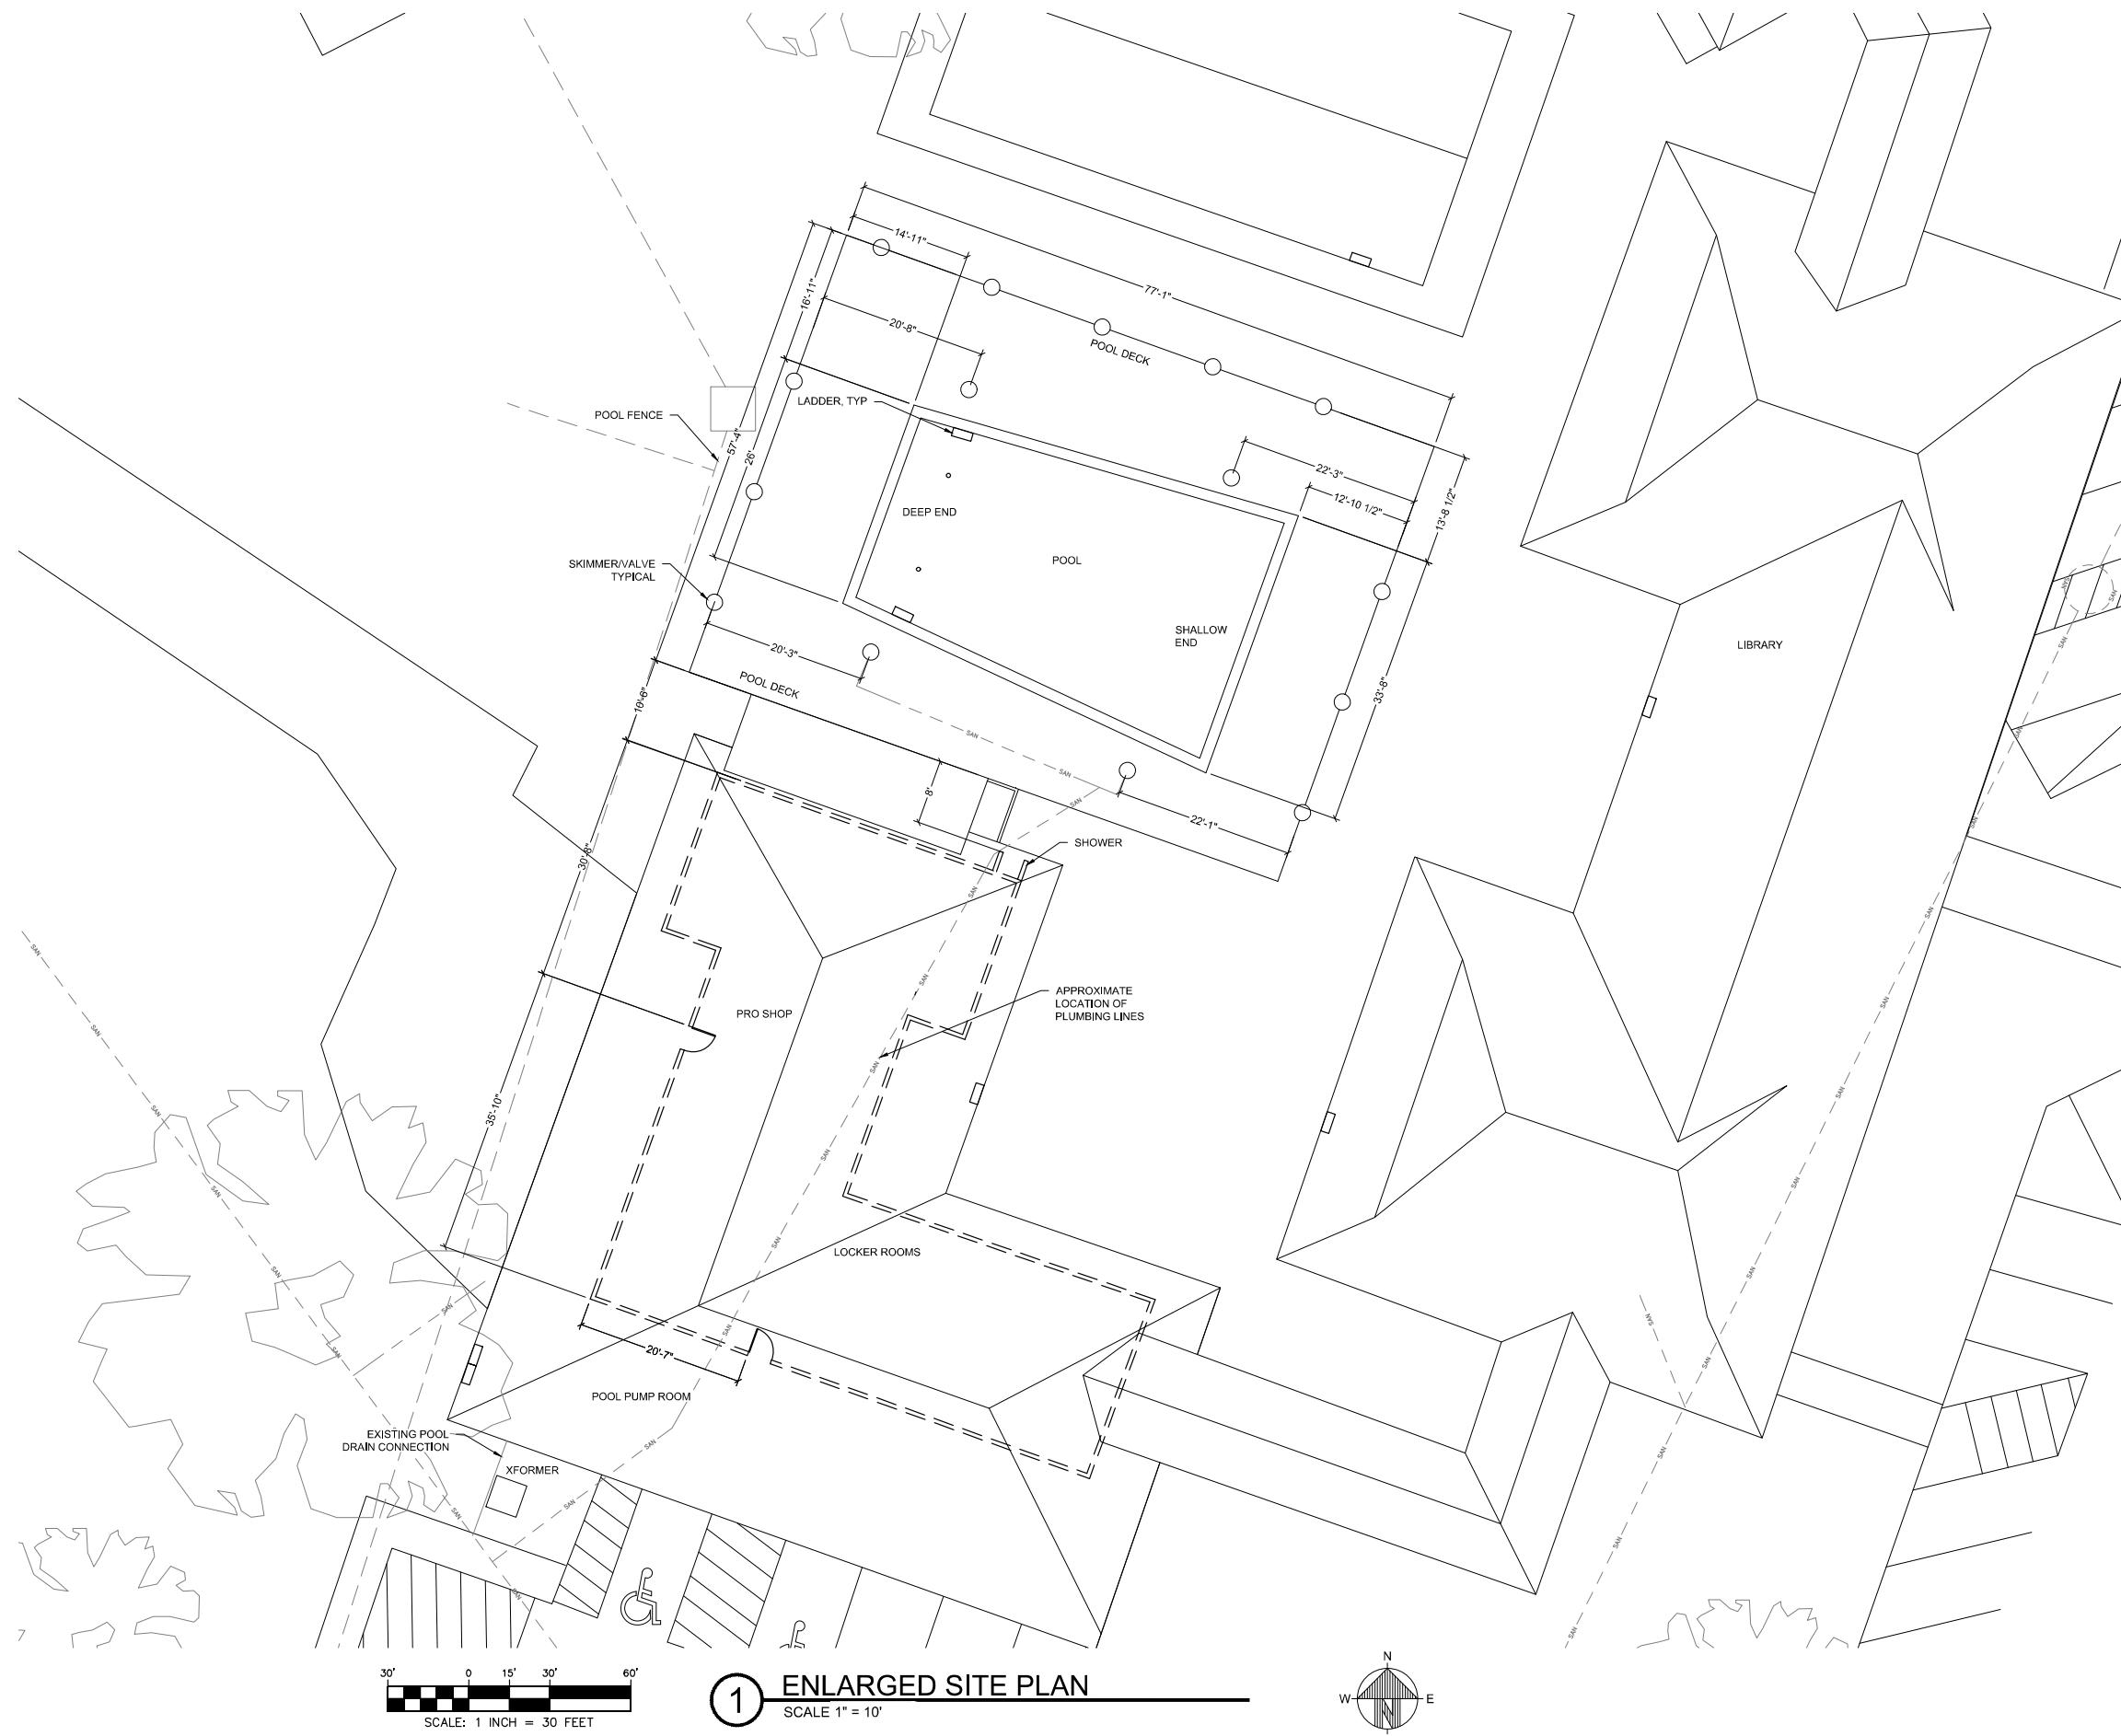
## ENLARGED PLAN - EXISTING CONDITIONS

The piping from the pump room to the pool is under the pro shop building and pool deck. The supply and return lines are reportedly 3" copper lines. The pool drain line also runs under the pro shop. The drain pipe is also 3" copper pipe and the top of the pipe was observed when the outdoor shower was installed. The pipe also was observed to contain several 90-degreee fittings.

The five valves on the pool deck have had their valve stems replaced, however, the parts for the valve stems are no longer available. The valves all connect to copper pipe that runs under the pool deck. The pool deck is concrete. The pool has tile around the waterline. The pool heater is also at the end of its life expectancy.
