Aquatic Center pool update

05- 13-2025

There are 2 parts to the Aquatic Center pool repairs and 2 companies doing the work. 1. Dehumidifier in mechanical room 2. Tile wall and floor repairs in showers, locker rooms and bathrooms.

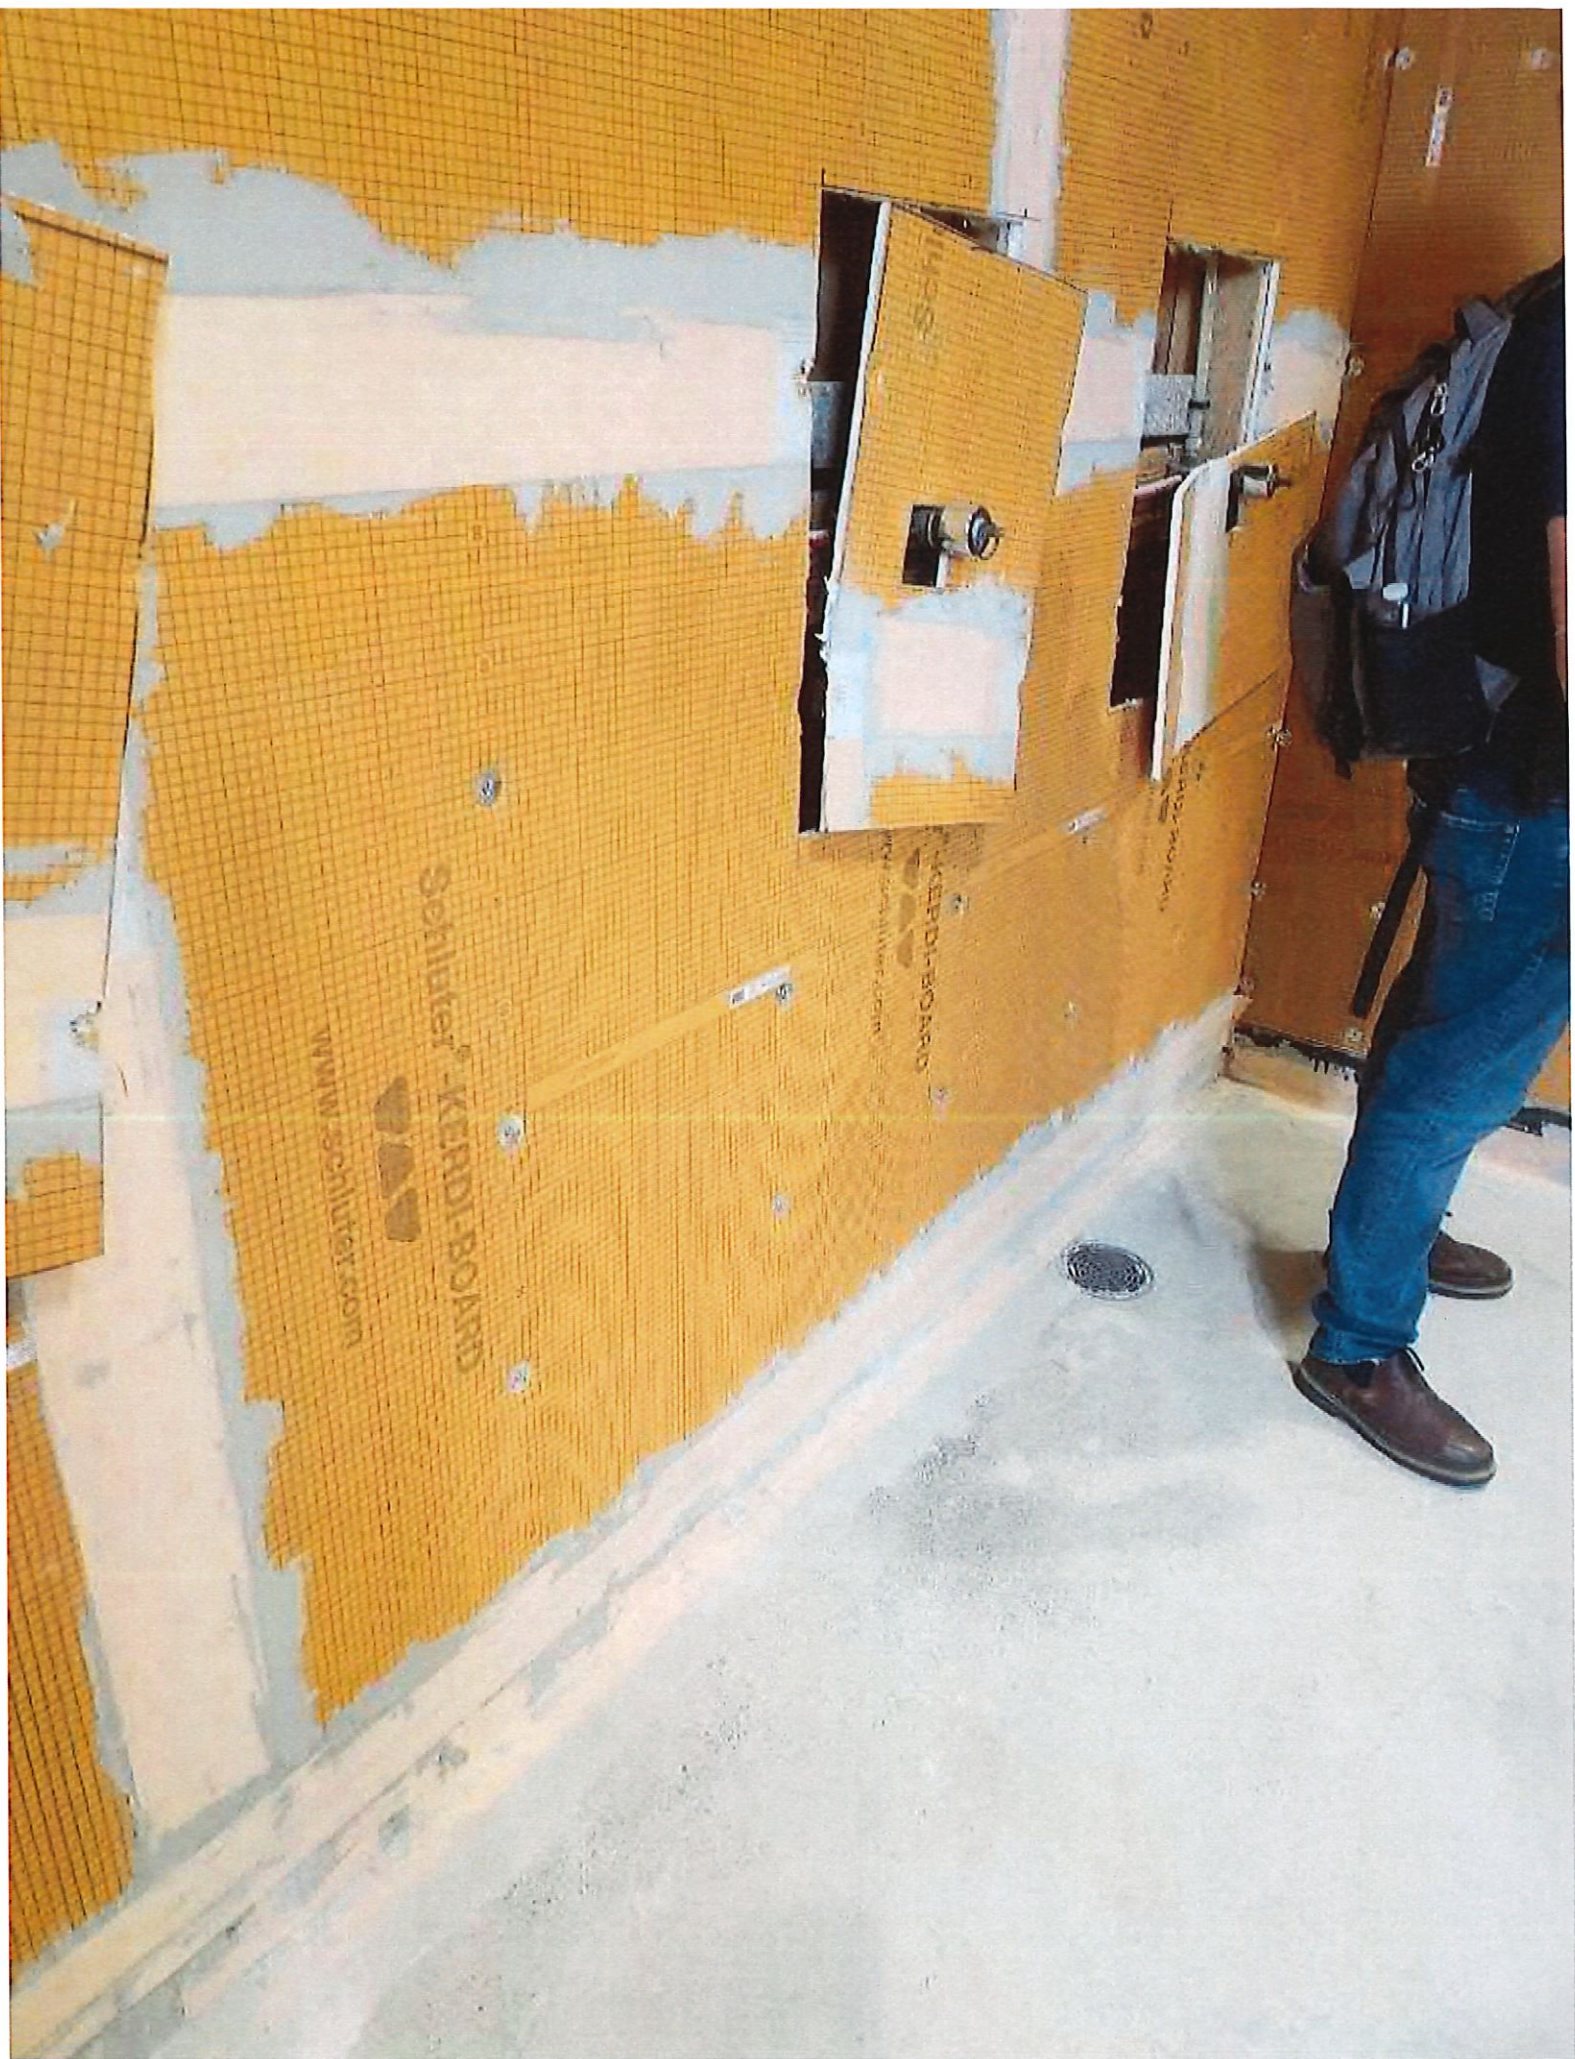
General contractor removed the tile about 16" to 20" up the wall in the changing areas and installed a Schleder (vapor barrier) product on the wall that goes down wall and onto the floor a few inches. This is to prevent water from getting into the wall when the floors are cleaned.

Schlüter®-KERDI-BOARD
www.schluter.com
