# **KING CITY CIVIC CENTER**

## **CLUBHOUSE POOL ASSESSMENT**

Bradford Consulting Engineers, Inc.

January 23, 2024

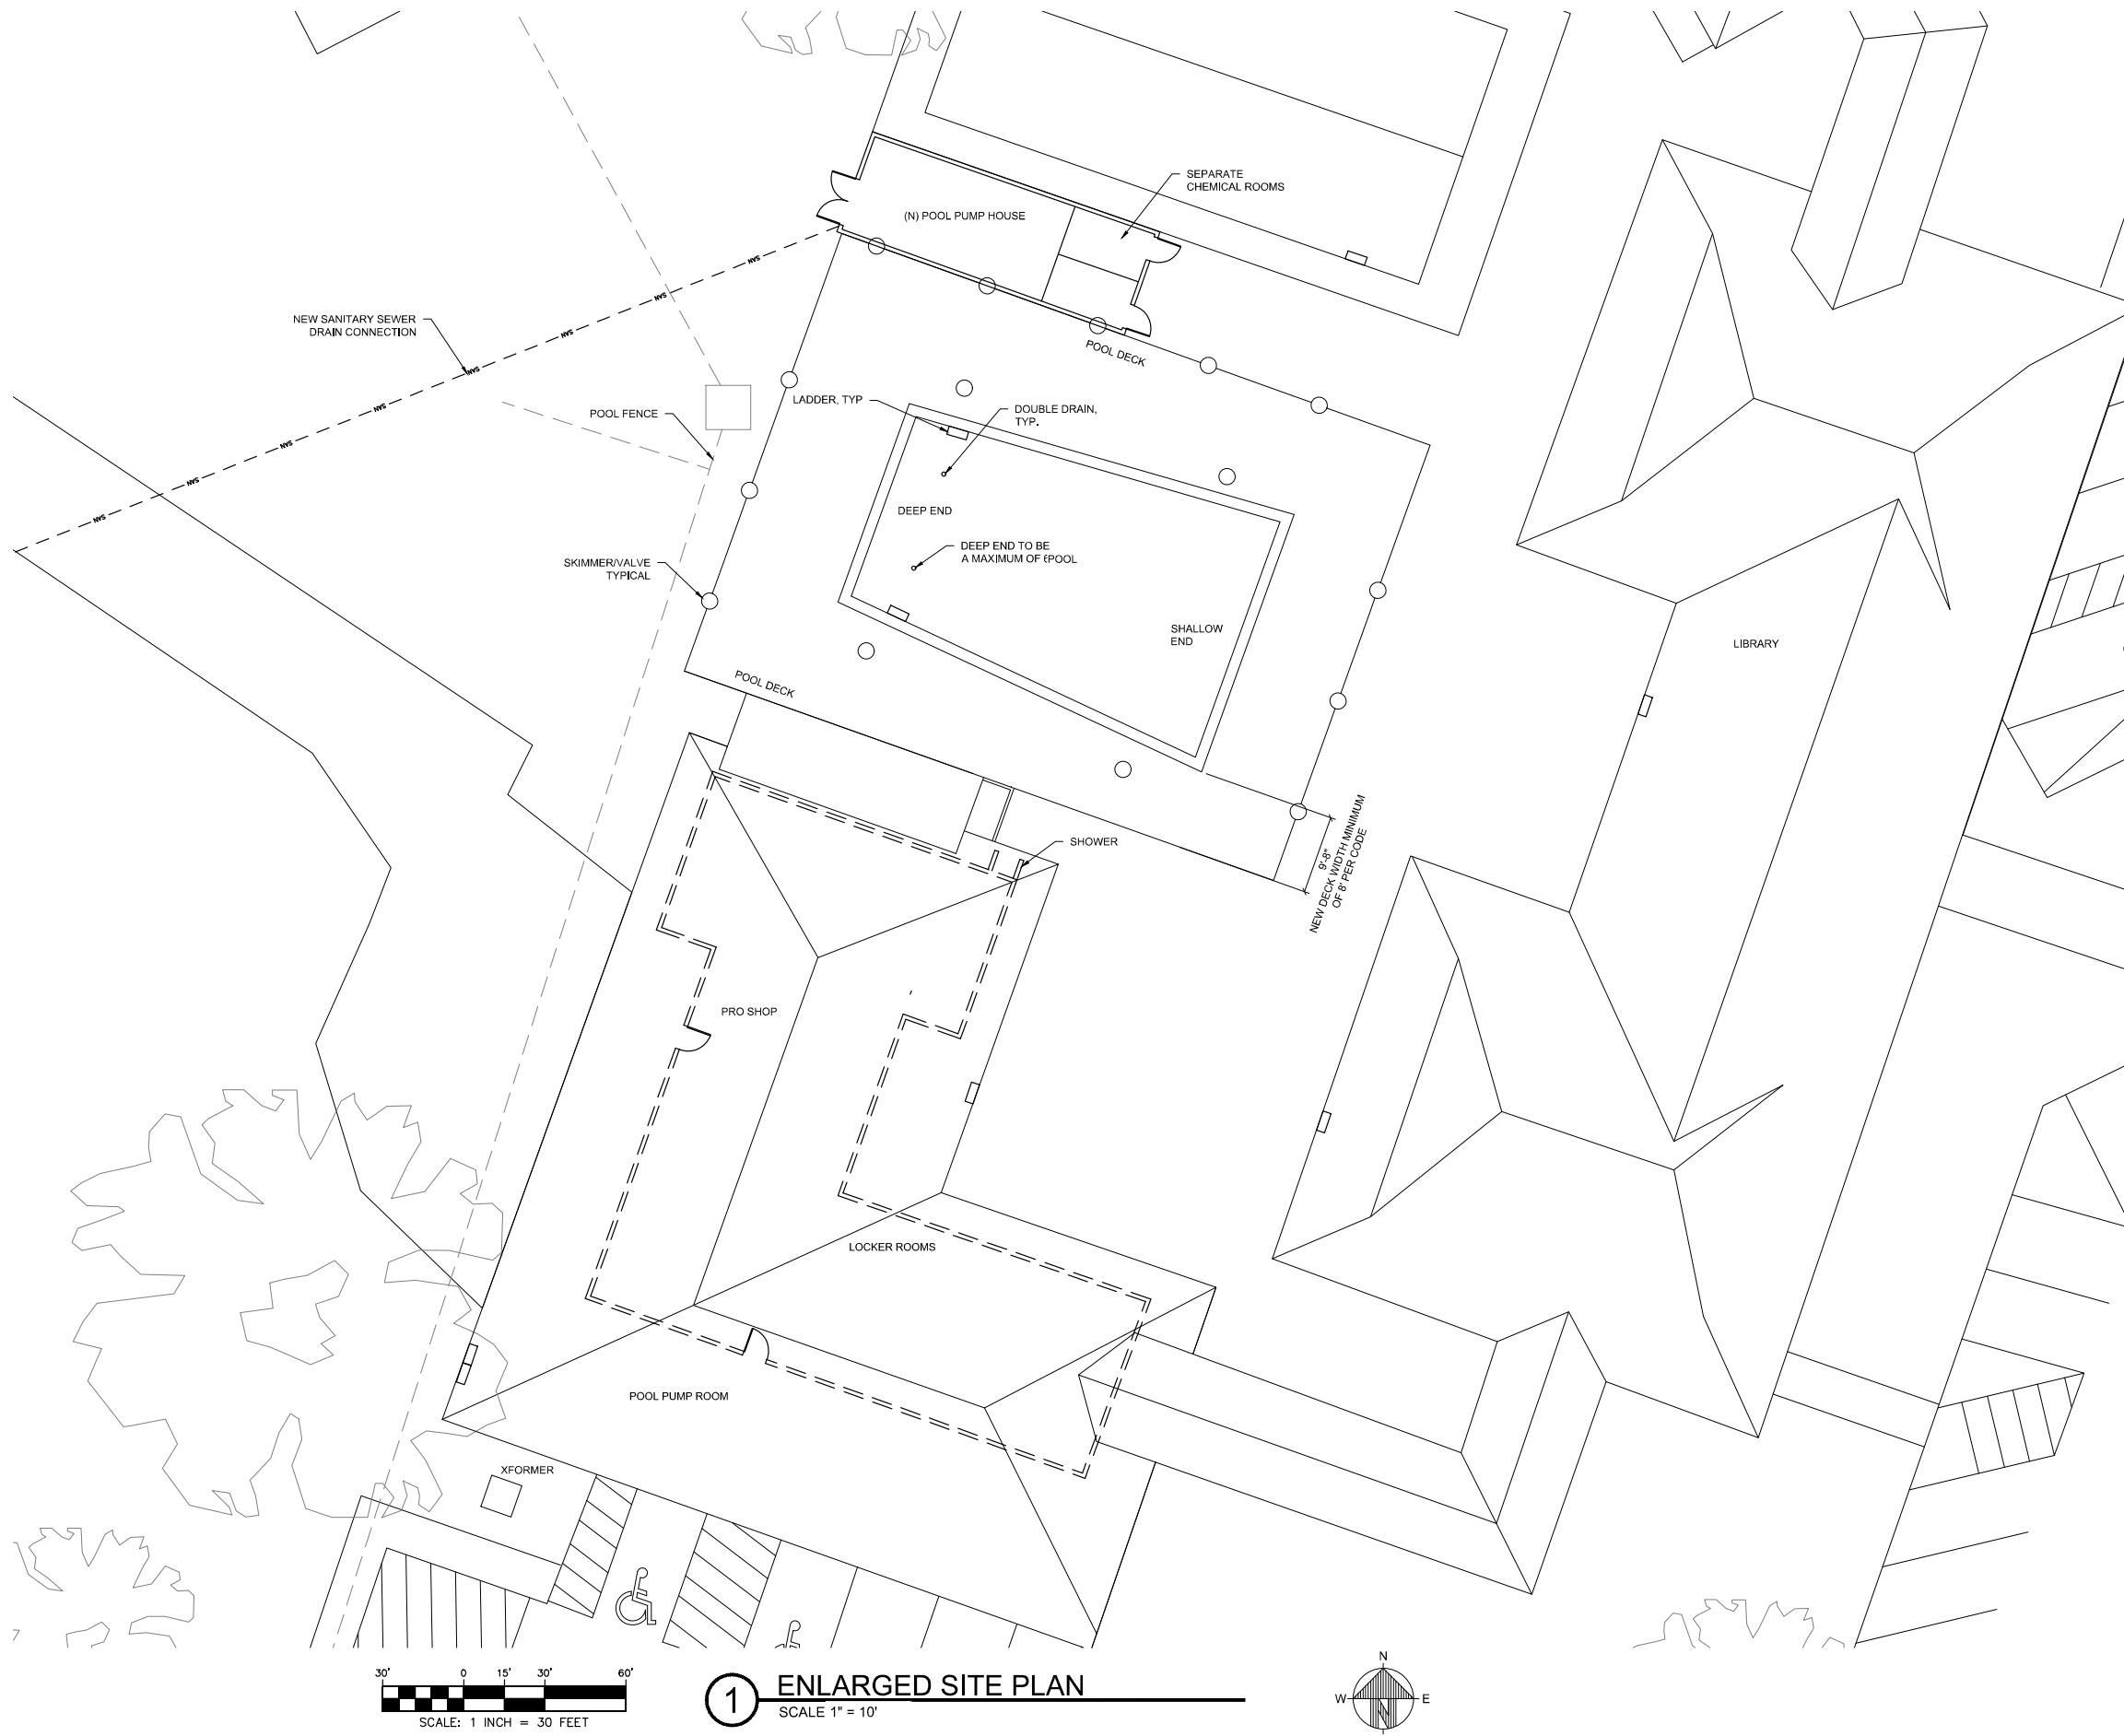
PROJECT NO: 23051  
DRAWING NUMBER:  
**G003**

The piping from the pump room to the pool is under the pro shop building and pool deck. The supply and return lines are reportedly 3" copper lines. The pool drain line also runs under the pro shop. The drain pipe is also 3" copper pipe and the top of the pipe was observed when the outdoor shower was installed. The pipe also was observed to contain several 90-degreee fittings.

The five valves on the pool deck have had their valve stems replaced, however, the parts for the valve stems are no longer available. The valves all connect to copper pipe that runs under the pool deck. The pool deck is concrete. The pool has tile around the waterline. The pool heater is also at the end of its life expectancy.
